In Reply Refer To: HSA-10/B-82B

In your March 7 letter, you requested formal Federal Highway Administration's acceptance of your Brifen Wire Rope Safety Fence (WRSF) as an National Cooperative Highway Research Program (NCHRP) Report 350 test level 4 (TL-4) traffic barrier. To support this request, you also submitted reports detailing two tests conducted by MIRA test laboratory, entitled "Vehicle Impact into the Standard Length of a Brifen Safety Fence to the NCHRP Report 350 Test 4-10" and "Vehicle Impact into the Standard Length of a Brifen Safety Fence to the NCHRP Report 350 Level 4-12," and digital videos of the tests themselves.

In summary, your Brifen WRSF, as described above, is acceptable as a TL-4 traffic barrier and may be used on the National Highway System when such use is specified by the contracting agency. I understand that all steel components of the TL-4 design, as with the TL-3 WRSF, are manufactured in the United States (U.S.) with U.S. steel and are not subject the Buy America provisions of Title 23, U.S. Code (USC), Section 635.410. However, both designs are proprietary and, as such, their use on Federally-funded projects remains subject to the conditions lis

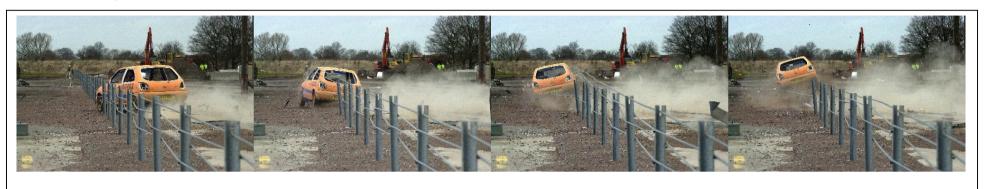
Figure 8: Summary of Results for Test MIRA-05-1008159 (D0002).

General Information		Impact Conditions			Test Article Deflections	(Deflection of Traffic face)	
Test Age	ency	MIRA Ltd	Speed (	(km/h)	100.8 km/h	Dynamic (m)	1.35m
Test No		D0002	Angle (d	deg)	21.3deg	Permanent (m)	0m
Date		10 January 2005	Exit Conditions			Vehicle Penetration (m)	1.35m
Test Article			Speed (km/h)		Not measured	Vehicle Damage – Exterior	
Туре		Brifen Safety Fence	Angle (deg)  Occupant Risk Values		Not measured	VDS	N/a
Installation	on Length (m)	275m Total 157m Full height	THIV (k	m/h)	19.94 km/h*	CDC	N/a
Size and/or dimension and material of key elements		Post Specing 2.2m	PHD (g)		5.07g*	Vehicle Damage – Interior	AS0000000
		Post Spacing 3.2m	ASI		0.55	OCDI	
Soil Type and Condition		Concrete post foundations 250mm diameter x 750mm deep in compacted AASHTO M147-65 standard soil.	OIV				
Test Vehicle				x direction	3.73m/s	Post Impact Vehicular Behaviour	
Туре		3 Door Hatchback	y direction		-4.09 m/s

Designation		Ford	ORA	,		Max Roll Angle (deg)	0.0* (CFC60 filter)
Model		Fiesta		x direction	3.53g	Max Pitch Angle (deg)	0.0* (CFC60 filter)
Mass	Kerb (kg)	927		y direction	0.91g	Max Yaw Angle (deg)	0.0* (CFC60 filter)
	Test Inertial (kg)	807		·			
	Total Ballast (kg)	N/A

Test summary sheets for the two tests you conducted are shown in enclosure 2. In the small car test, although successful, several of the concrete footings pulled out of the ground, negating the supposed maintenance benefit of using socketed posts. To reduce the likelihood of this occurrence, you recommended increasing the footing size from its tested 250-mm diameter to a 300-mm diameter, with its depth remaining at 750 mm. Deeper footings can be used in soft or saturated soils to improve system maintainability, the use of which would not need any

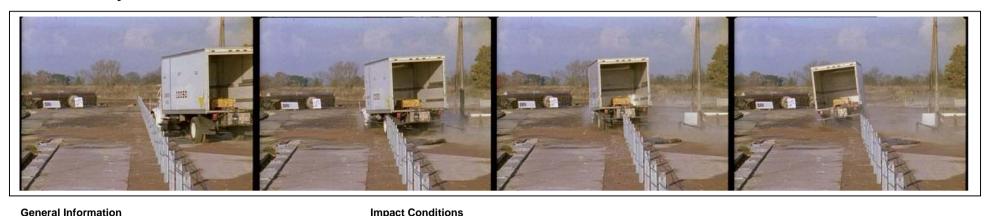
Figure 8: Summary of Results for Test MIRA-04-1007578 (C0050).

rai illiorillation		impact	Conditions				
Agency MIRA Ltd		Speed (km/h)		79.7 km/h	Vehicle Damage – Exterior		
t No C0050		Angle (deg)		15.8deg	VDS	N/a	
	29 November 2004	Exit Conditions			CDC	N/a	
Article		Speed (km/h)		Not measured	Vehicle Damage – Interior		
	Brifen Safety Fence	Angle (deg)		Not measured			
lation Length (m)	275 (Nom)	Occupant Risk Values			Post Impact Vehicular		
and/or dimension and	Post Spacing 3.2m	THIV (km/h)		7.09 km/h	Behaviour		
ial of key elements		PHD (g)		5.09g	Max Roll Angle (deg)	5.0 (CFC60 filter)	
ype and Condition	Concrete post foundations 250mm	ASI OIV		0.18	Max Pitch Angle (deg)	6.0 (CFC60 filter)	
	AASHTO M147-65 standard soil.				Max Yaw Angle (deg)	20 (CFC60 filter)	
Vehicle			x direction	0.77m/s			
	8T rigid truck	y direction		1.85 m/s	<b>Test Article Deflection</b>	tion	
nation	International	ORA			Dynamic	2.21m	
I	Harvester		x direction	0.49g	Permanent	0.00m	
Kerb (kg)	6105		y direction	1.44g

Test Inertial (kg)	8050						
Total Ballast (kg)	1945						
Gross Static (kg)	8050						
֡֡֜֜֜֜֜֜֜֜֜֜֜֜֜֜֜֜֜֜֜֜֜֜֜֜֜֜֜֜֜֜֜֜֜֜֜	Agency No  Article  ation Length (m) and/or dimension and ial of key elements  Type and Condition  Vehicle  nation I  Kerb (kg) Test Inertial (kg) Total Ballast (kg)	Agency MIRA Ltd C0050 29 November 2004  Article Brifen Safety Fence ation Length (m) 275 (Nom) And/or dimension and ial of key elements Concrete post foundations 250mm diameter x 750mm deep in compacted AASHTO M147-65 standard soil.  Vehicle 8T rigid truck International Harvester Kerb (kg) 6105 Test Inertial (kg) 8050 Total Ballast (kg) 1945	Agency MIRA Ltd Speed ( No C0050 Angle (c 29 November 2004 Exit Co Speed ( Article Brifen Safety Fence Angle (c ation Length (m) 275 (Nom) Occupa and/or dimension and ial of key elements  Type and Condition Concrete post foundations 250mm diameter x 750mm deep in compacted AASHTO M147-65 standard soil.  Vehicle  8T rigid truck nation International ORA  Kerb (kg) 6105 Test Inertial (kg) 8050 Total Ballast (kg) 1945	Agency MIRA Ltd Speed (km/h) No C0050 Angle (deg) 29 November 2004 Exit Conditions Speed (km/h) Article Speed (km/h)  Brifen Safety Fence Angle (deg)  ation Length (m) 275 (Nom) Occupant Risk Values THIV (km/h) Post Spacing 3.2m  Concrete post foundations 250mm diameter x 750mm deep in compacted AASHTO M147-65 standard soil.  Vehicle ST rigid truck y direction  Nation International International  Kerb (kg) 6105 y direction Test Inertial (kg) 8050 Total Ballast (kg) 1945	Agency MIRA Ltd Speed (km/h) 79.7 km/h No C0050 Angle (deg) 15.8deg 29 November 2004 Exit Conditions  Article Speed (km/h) Not measured  Exit Conditions Speed (km/h) Not measured  Angle (deg) Not measured  THIV (km/h) 7.09 km/h PHD (g) 5.09g  ASI 01.8  ASI 01.8  ASI 01.8  ASI 01.8  Wehicle x 750mm deep in compacted AASHTO M147-65 standard soil.  X direction 0.77m/s  y direction 0.49g  Kerb (kg) 6105 y direction 1.44g  Test Inertial (kg) 8050  Total Ballast (kg) 1945	Agency MIRA Ltd Speed (km/h) 79.7 km/h Vehicle Damage – Exterior No C0050 Angle (deg) 15.8deg VDS  29 November 2004 Exit Conditions CDC  Article Fife Safety Fence Angle (deg) Not measured Vehicle Damage – Interior Post Speed (km/h) Not measured Vehicle Damage – Interior Post Speed (km/h) Not measured Post Impact Vehicular Behaviour Post Spacing 3.2m PhD (g) 5.099 km/h PhD (g) Speed Condition Concrete post foundations 250mm diameter x 750mm deep in compacted AASHTO M147-65 standard soil.  Asi OIV  Vehicle Fife Safety Fence ASI rigid truck Vehicular Speed (km/h) Not measured Post Max Roll Angle (deg) Max Roll Angle (deg) Max Roll Angle (deg) Max Pitch Angle (deg) Max Yaw Angle (deg) Max Yaw Angle (deg) OIV  Vehicle Vehicle Fife Safendard Soil. Velicetion Not Max Pitch Angle (deg) Max Yaw Angle (deg) Max Yaw Angle (deg) OIV  Vehicle Vehicle Fife Safendard Soil. Velicetion Not Max Pitch Angle (deg) Max Yaw Angle (deg) OIV  Vehicle Vehicle Fife Safendard Soil. Velicetion Not Max Pitch Angle (deg) Max Yaw Angle (deg) OIV  Vehicle Vehicle Fife Safendard Soil. Velicetion Not Max Pitch Angle (deg) Not Max Yaw Angle (deg) OIV  Vehicle Vehicle Fife Safendard Soil. Velicetion Not Max Pitch Angle (deg) Not Max Yaw Angle (deg) OIV  Vehicle Vehicle Fife Safendard Soil. Velicetion Not Max Pitch Angle (deg) Not Max Yaw Angle (deg) OIV  Vehicle Vehicle Fife Safendard Soil. Velicetion Not Max Pitch Angle (deg) Not Max Yaw Angle (deg) OIV  Vehicle Fife Safendard

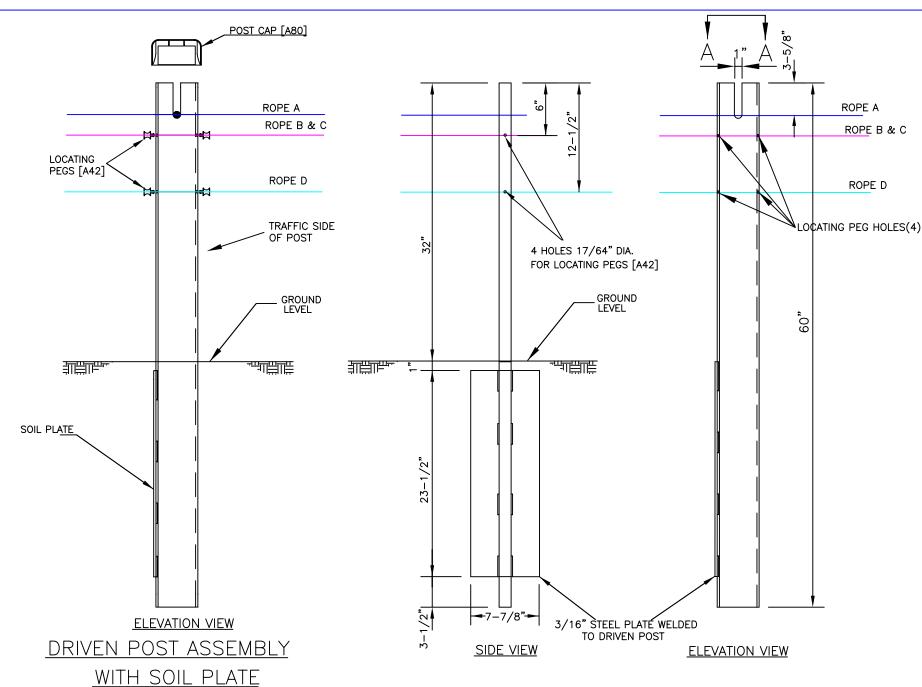
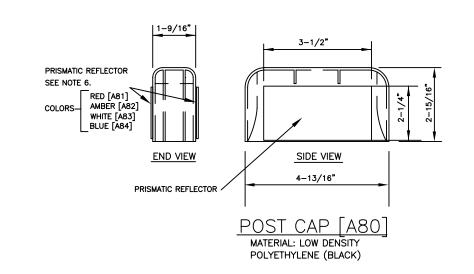
DRIVEN LINE POST [A21L]

"L" & "R" POST ORIENTATION

LEFT HAND POST [A21L] RIGHT HAND POST [A21R]

("L" POST SHOWN)

LOCATING PEG [A42]

additional approval action. If you use driven posts with soil plates with the TL-4 design, these posts must have the same cross-section noted above for the TL-4 system and have the same below-ground geometry as is now specified for the TL-3 barrier, shown for convenience as enclosure 3. If you wish also to utilize steel sockets driven directly into the ground, you will first need to specify the size and depth you recommend, and provide an analysis showing equivalency with the approved designs. Design deflection with the small car was 1.35 m. With the single unit truck, it was reported to be 2.21 m. Presumably, deflection with the pickup truck would be similar to that noted in your earlier TL-3 test and thus may be assumed to be approximately 2.4 m.
